Winter excursion of the Swiss Young Geomorphologists (SGmS)

Brig – Simplon Pass, 15-16 February 2019

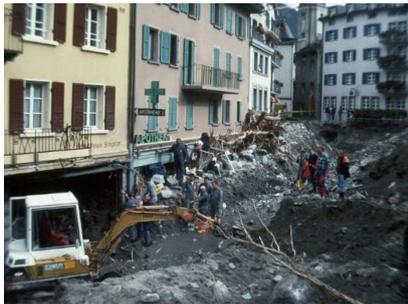
Fig. 1. Damages in the Brig center during the flood in 1993.

The Saltina is a small river crossing Brig in a channel of 15 m width before flowing into the Rhone river. In 1993, following abundant rainfall, the river overflowed because the main bridge was obstructed by transported materials. Water, mud, debris and wood flooded the Brig center until 3 m of height in some points and two people died (Fig. 1 and 2). The damage costs amounted to 500 million Swiss Francs. After this event, in the Grindji area upstream of Brig, 100 000 m³ of material were carried away to create two deposit areas and the Saltina channel walls were raised. Then a new mobile bridge (Fig. 3) was built instead of the old one: it can lift itself off by 3 m in case of flood, avoiding an overflow. When the river reaches a certain height, the water goes through a small lateral channel to a steel basin. This reservoir of 50 m³, when full, sinks into the constructed well for this purpose. Thanks to a system of cables and pulleys, it raises the 152 tons of the bridge in 6 minutes. In other words, the river itself maintains its freedom of flow and, if the automatic device does not work, the tank manually can be full manually. In 2000, the Saltina level increased due to high rainfall but the new bridge, which lifted itself, avoided city flood (Fig. 4).

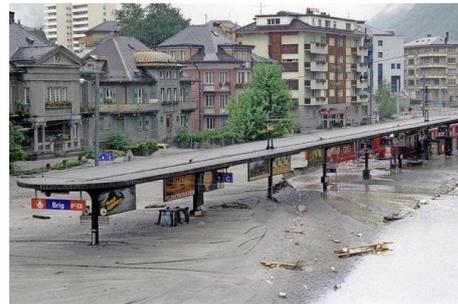
Fig. 2. Damages at the Brig train station (flood 1993).

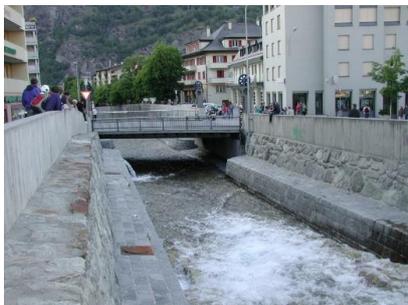
Fig. 3. The new mobile bridge built after the flood in 1993.

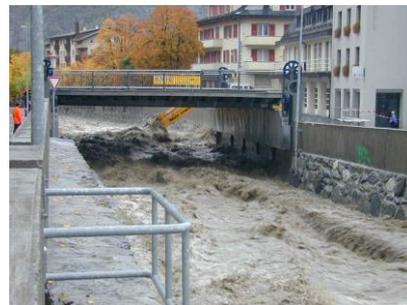
Fig. 4. Lifted bridge during the flood in 2000.
